# Landsliding in an urban area

Phil Flentje & Robin Chowdhury

Research Fellow and Professor, Faculty of Engineering, University of Wollongong, Wollongong, NSW 2522, Australia

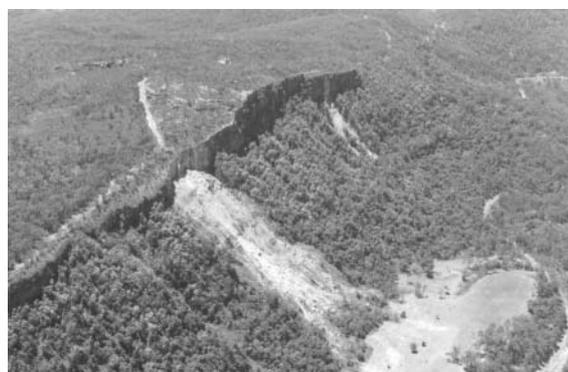
Fig. 2. Escarpment with large rock fall debris flow near Dombarton railway siding, 1974. Photo by Young.

The escarpment consists of slopes with moderate to steep inclinations with several intermediate benches and cliff lines. Spectacular cliffs of Hawkesbury Sandstone (Middle Triassic) cap the escarpment and there is dense vegetation over most of the escarpment below these cliffs (Fig. 2).

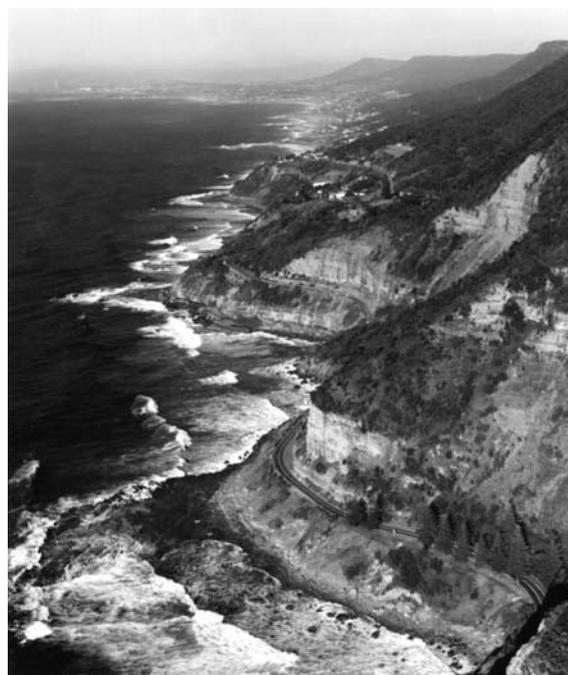
Fig. 3. View south from northern suburbs. Lawrence Hargrave Drive in foreground near base of cliff.

The main road link to Sydney is the F6 freeway that traverses the escarpment via Mount Ousley Road. There are several other road links from the coastal plain to the top of the escarpment and there is a coast road to the north (Figs 3 & 4).

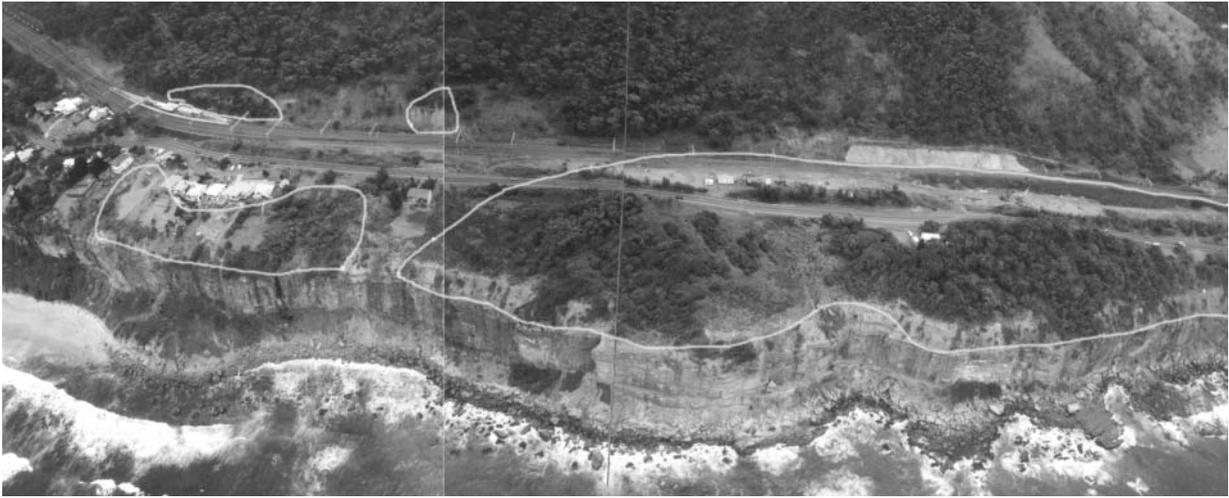
**Fig. 4.** Northern Coalcliff terrace and known instability, with the dual railway line, Lawrence Hargrave Drive and residential properties. Photo by Flentje 1992.

The complex and composite slide-flow category poses a significant challenge to land management in the hilly suburbs of Wollongong (Fig. 4). Between major rainfall events these landslides typically move extremely slowly (16 mm per year according to WP/WLI (Working Party on World Landslide Inventory) 1995 in a 'slip and stick' fashion. Their re-activation leading to disruptive landsliding is a progressive, time-dependent and rainfall-triggered process.

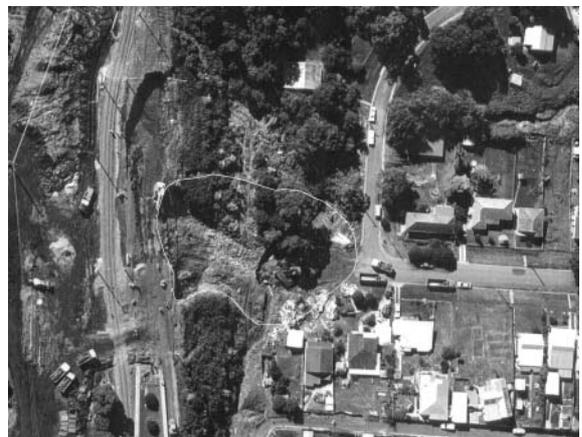
**Fig. 5.** Coledale Railway Station and Rawson Street Coledale debris flow, 30 April 1988. Photo by SRA.

An interesting example of other landslide types include the collapse of a 17 m high railway embankment at Coledale in the northern suburbs on the 30 April 1988 (Fig. 5). The slip surface first developed in the natural slope below the embankment and the catastrophic failure was caused by blocked drainage uphill and high pore water pressures in a layer of ash forming part of the embankment.

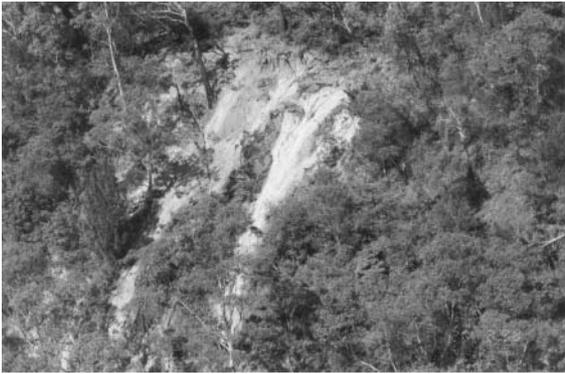
**Fig. 6.** Close-up of one of several debris-flow source areas along toe of the deep seated slow moving Mount Kembla landslide, 20 August 1998. Photo by NSW Police.

During a recent rain-storm event in Wollongong, in August 1998, debris flows caused significant disruption to the city. Two debris flows inundated the suburb of Keiraville damaging several houses in their paths. Another debris flow that occurred during the night of the 20 August 1998 resulted in the 12 hour evacuation of a portion of the village of Mt Kembla, including approximately 50 houses and 130 residents (Fig. 6).

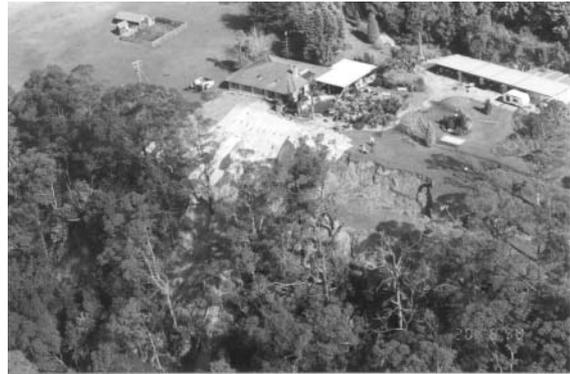
**Fig. 7.** Complex slide-flow near residence above Harry Graham Drive in Mt Kembla, 20 August 1998. Photo by NSW Police.

A complex debris slide-debris flow developed adjacent to a residence near Mount Kembla during the evening of the 17 August 1998 (Fig. 7). The rear main scarp of this landslide was approximately 7 m high. The displaced mass flowed downslope inundating a road that remained blocked for approximately 24 hours.
